Case Studies in Construction Materials

Retrofitting technique effectiveness and seismic performance of multi-rise RC buildings: A case study

Turgay Cosgun^a, Baris Sayin^{a,*}, Baris Gunes^a, Atakan Mangir^b

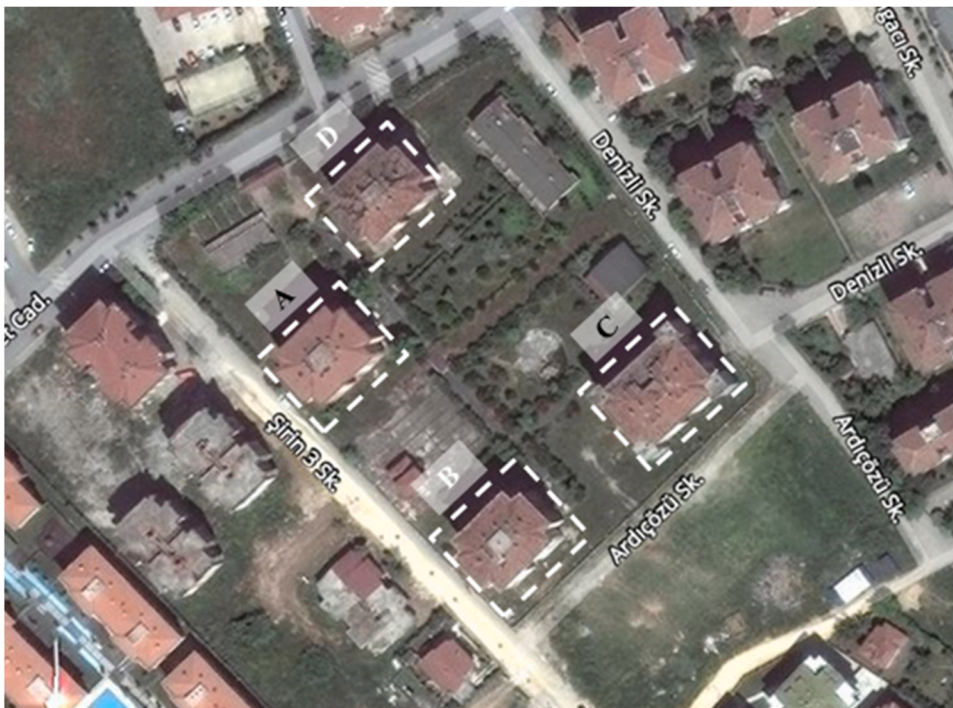
Fig. 1. Aerial view of the buildings A to D.

The examined buildings are located in the Büyükcçekmece region of Istanbul, Turkey. There are four similar 10–11 storey multi-rise RC buildings in the study area, Building A, B, C, and D (Fig. 1). These buildings have been idle for 30 years since the construction, and one of them (Building C) was recently retrofitted. Buildings have identical properties in terms of plan geometry and structural system layout. Building A and retrofitted Building C are examined in this paper to evaluate the effectiveness of the retrofitting technique applied (Figs. 2 and 6). Detailed field studies, laboratory tests and numerical analyses are carried out for these two buildings. In field surveys, on-site measurements are made, including the positions and dimensions of the structural elements, and the conformity of the structural system to the design project is checked. The existing concrete strength and rebar arrangement of old and new structural elements are examined by sampling and laboratory tests. In addition, damage on the structural members is visually checked by on-site observations.

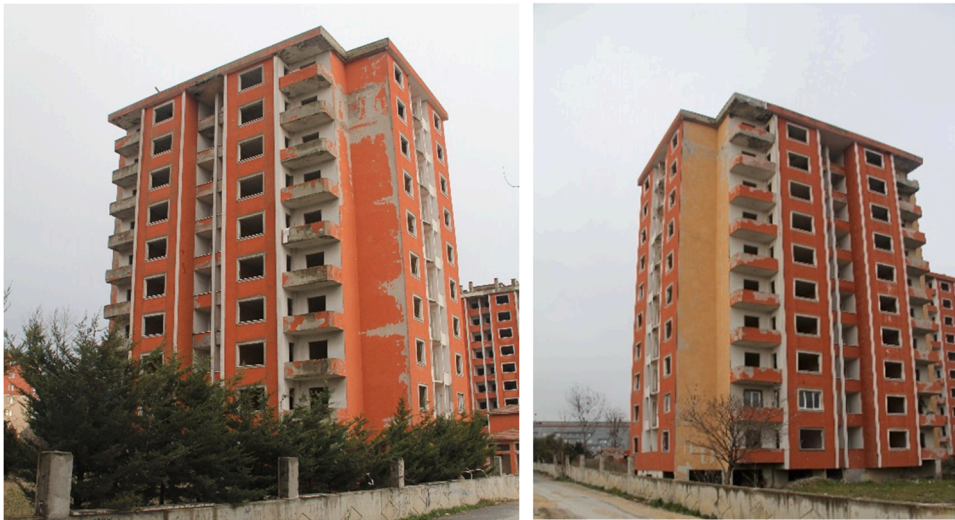
Fig. 2. Overview of Building A.

Building A consists of 11 floors, including a basement, ground floor and nine standard floors (Fig. 2). The primary structural system of the building consists of an RC frame with shear walls. No discontinuities are observed in the structural members throughout the building. Building A sits on an area of 432 m² with 25.9 m x 16.2 m plan dimensions and has strip foundations in both directions. The storey height is measured as 2.80 m on all floors.

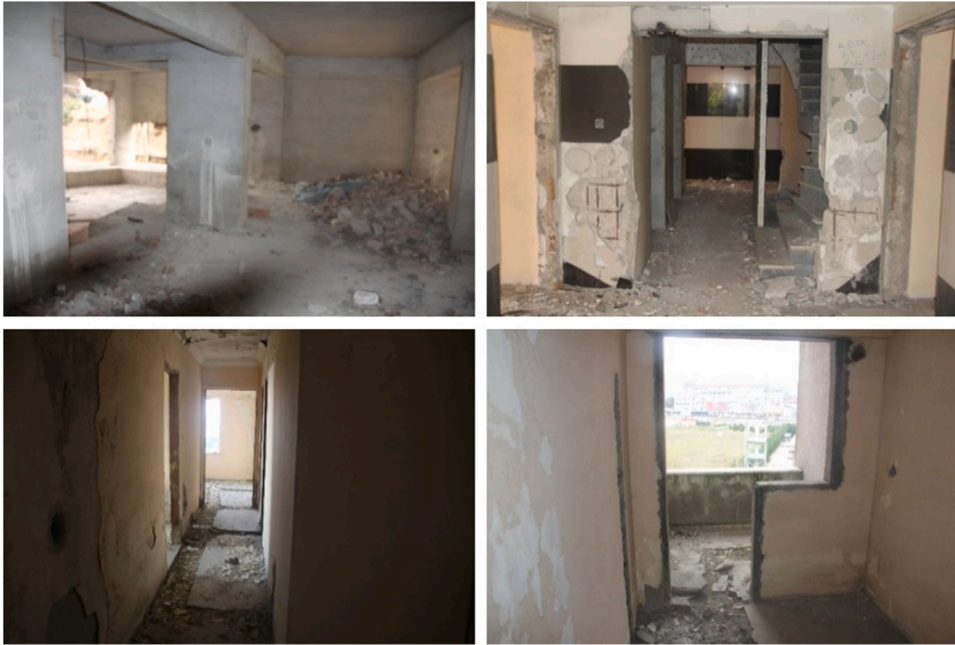
Fig. 4. Interior views from Building A.

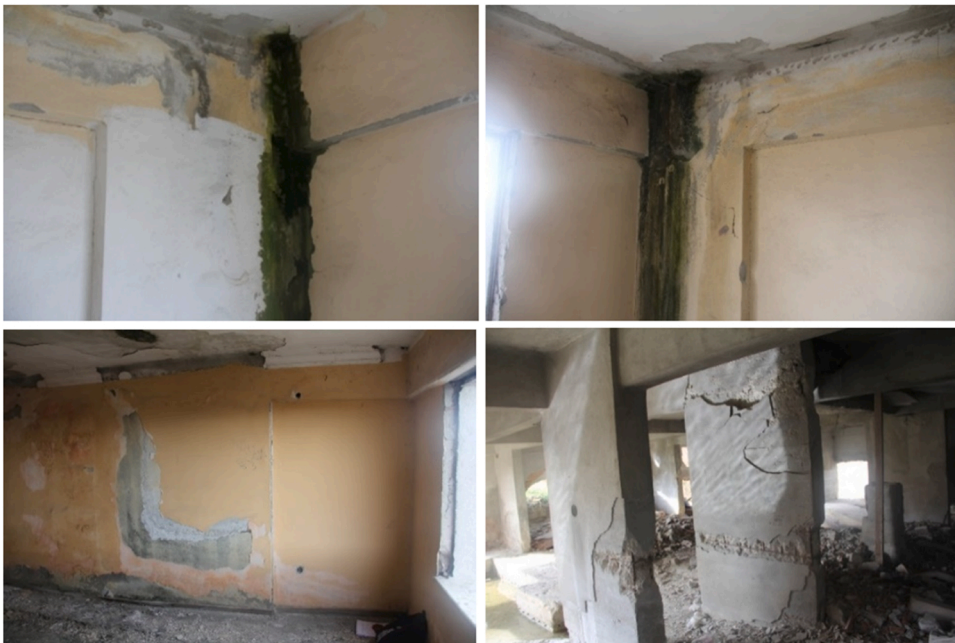
Fig. 5. Example of some defects in Building A.

Table 1 shows the measured dimensions of the structural members in Building A. The results of these measurements are compared with those specified in the original design project of the same building. It has been determined that measured values are suitable with the original design project. A typical floor plan and strip foundation plan from the design project is shown in Fig. 3. The interior views of the building are given in Fig. 4. In the investigations, swelling and spalling were observed on the mortar and paint layers of some columns, beams, flooring, and wall surfaces due to the effect of moisture. Examples of some defects in the building are given in Fig. 5. The loss in the diameter of some rebars due to corrosion and deterioration of concrete in some walls are shown in Fig. 4. As a result of the moisture effects, swelling and spalling in the mortar and paint layers of some beams, columns and walls are shown in Fig. 5.

In the examinations made, swelling and spalling were observed in the mortar and paint layers of some columns, beams, flooring, and wall surfaces due to the effect of humidity. In addition, corrosion effects are observed on the rebars of some structural elements after concrete stripping. No significant damage was found in either building. Examples of some defects found in the building are given in Fig. 8. Swelling and spalling due to the effect of moisture in the mortar and paint layers of some beams, columns, walls and floors are shown in Fig. 7. In the slab shown in Fig. 8, losses in diameters of some rebars due to corrosion and deterioration of concrete are shown.

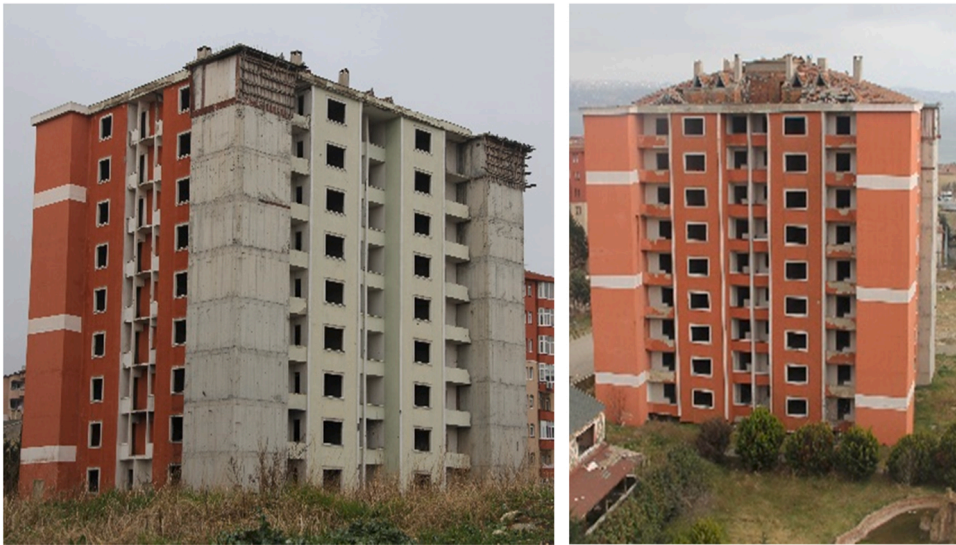
Fig. 6. Overview of Building C (retrofitted with shear walls).

Building C consists of 10 floors, including a basement, ground floor and eight standard floors (Fig. 6). The building's primary structural system, plan layout and floor heights are the same as Building A. No discontinuities are observed in structural members throughout the structure. The differences between the two buildings are the retrofitting process in Building C and the total number of floors (A-11, C-10). It is determined that the building is retrofitted with new reinforced concrete shear walls placed over the basement floor and at the four sides and corners of the building. As the retrofitting procedures were completed probably without any design project, on-site measurements helped to determine the length and thickness of the new walls. The new shear walls around the basement are 20 cm thick, while those in the four corners are 55–60 cm thick. It has been determined that the measured values for the dimensions of the existing structural members are in accordance with the original design project (Fig. 3). The interior views of the building are given in Fig. 7.

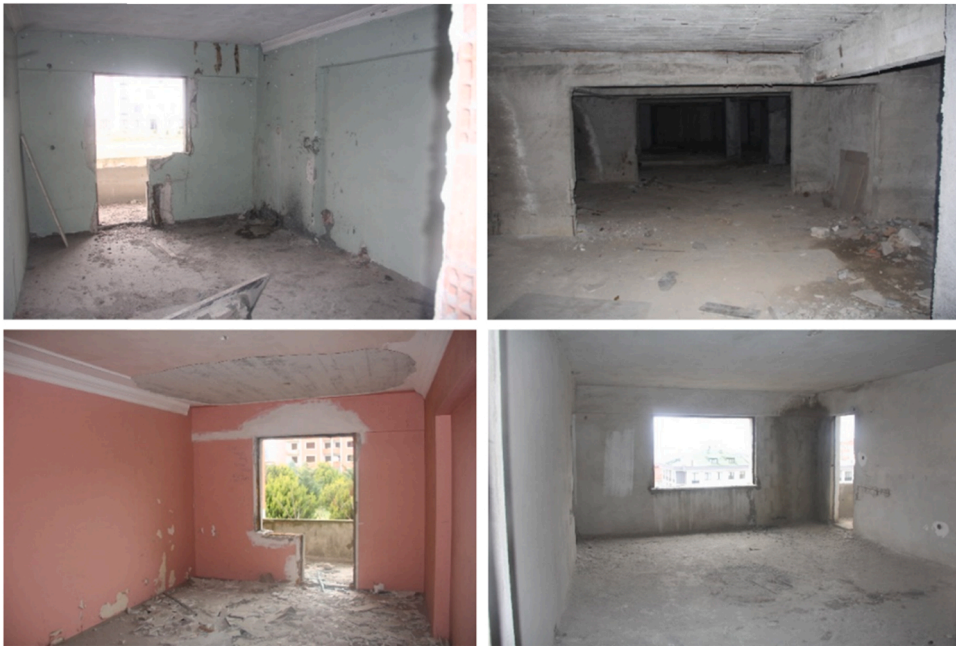
Fig. 7. Interior views from Building C.

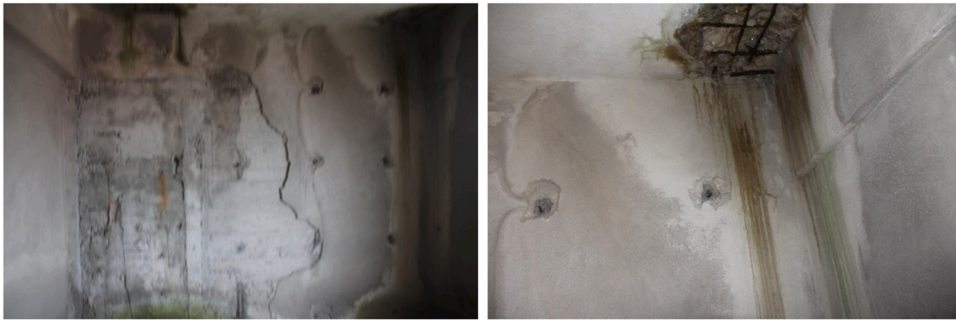
Fig. 8. Example of some defects in Building C.

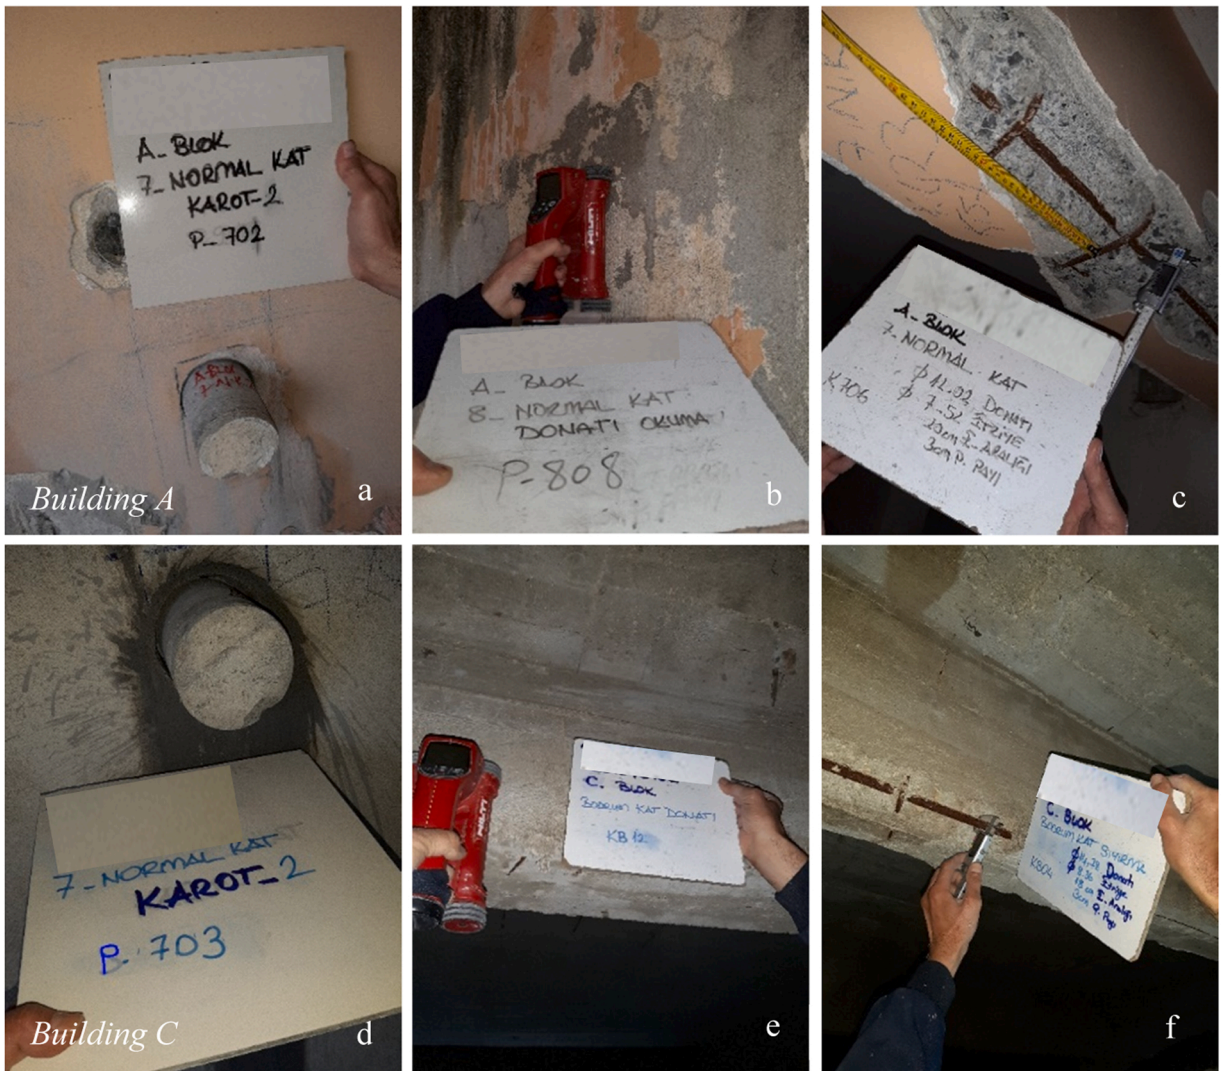
Fig. 9. Core sampling and rebar detection on Building A (a-c) and Building C (d-f).

In total, 44 (4/each floor) vertical structural members and 22 (2/each floor) beams were scanned with rebar scanners in Building A, and 40 (4/each floor) vertical structural members and 20 (2/each floor) beams were scanned with rebar scanners in Building C to obtain rebar arrangement data. In addition, four new shear walls were scanned on both the basement and ground floors of Building C. Details of the rebar arrangement of some members are presented in [Tables 7 and 8](#).

The concrete cover of one beam and three vertical structural members on each floor is stripped for visual inspections and measurements. With this method, a total of 33 vertical structural members and 11 beams were inspected in Building A, and 30 vertical structural members and 10 beams in Building C. In addition, in Building C, the concrete cover of these new members was stripped, and

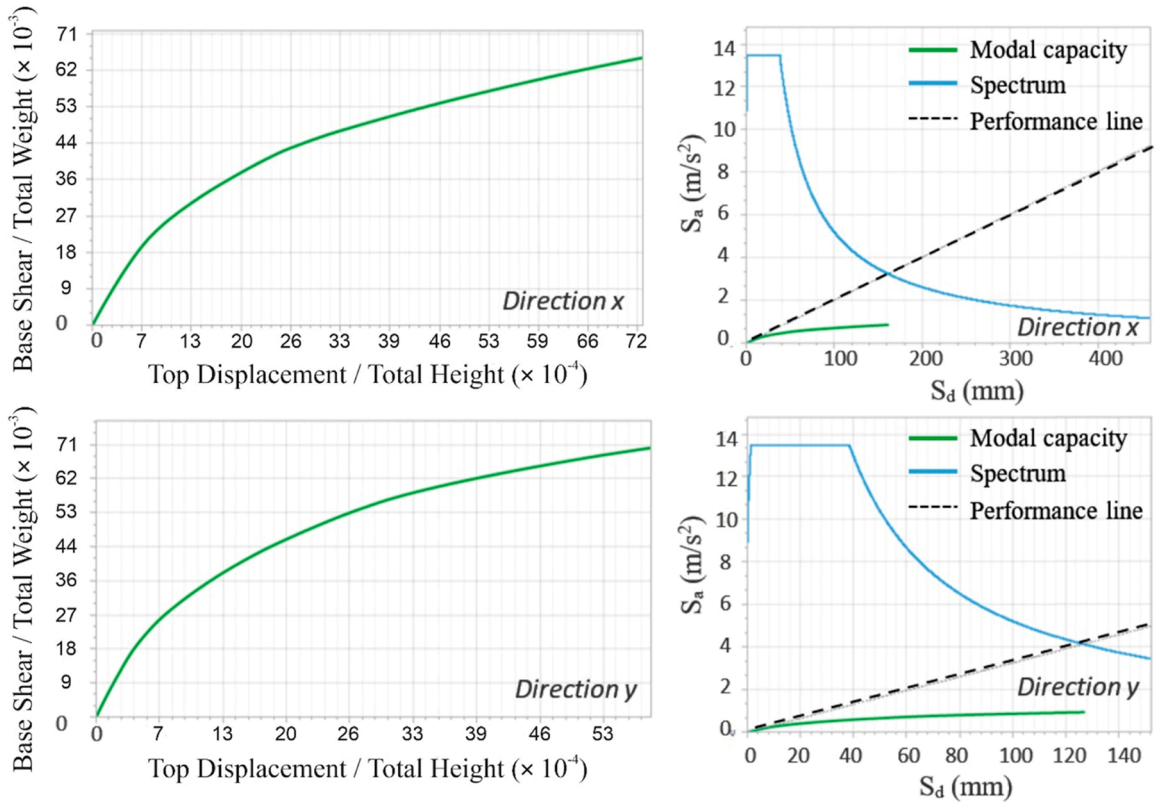
Fig. 13. Normalised base shear vs. top displacement and demand vs. capacity graphs of Building A.

Modal capacity curves of buildings are prepared using the pushover curves for both directions. The curves are drawn with the demand spectrum, and the performance point is determined according to the recommendations given in the code. At the performance point, the base shear/total weight and top displacement/total height, and demand spectrum and modal capacity curves (spectral acc./spectral disp.) under DD-2 earthquake are presented in Figs. 13 and 14 for two buildings. Lateral displacement contours in both directions at performance points of the buildings are shown in Figs. 15 and 16. When the behaviour of the two structures is examined, it is seen that Building A has reached the base shear values of 3645 kN and 3956 kN in X and Y directions, respectively.

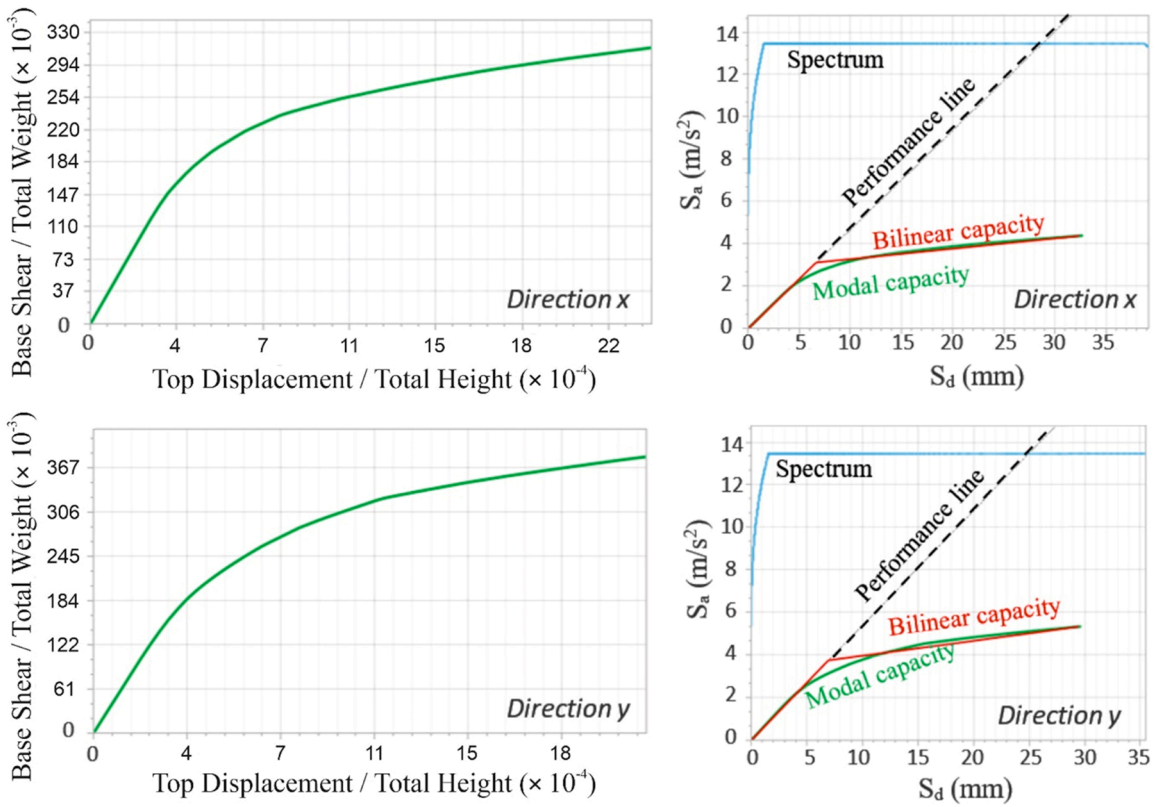
Fig. 14. Normalised base shear vs. top displacement and demand vs. capacity graphs of Building C.

On the other hand, Building C has reached the base shear values of 26,731 kN and 31,882 kN, respectively, in the same directions. The controllable performance points in the roof displacement values are changed from 220 mm to 65 mm, and from 180 mm to 60 mm levels in the X and Y directions when the displacement demands of two buildings are compared. It can be understandable that the new shear walls provide increased stiffness. The variation observed between the base shear values is 733% in the X direction and up to 806% in the Y direction. This increase shows the importance of ductility in the retrofitting design phase. Unfortunately, an increase in this amount strongly invites brittle failure mechanisms of reinforced concrete members. In other words, retrofitting is applied to
